VDOT - Infiltration Trench

Route 10, Hopewell, Virginia - July 2004

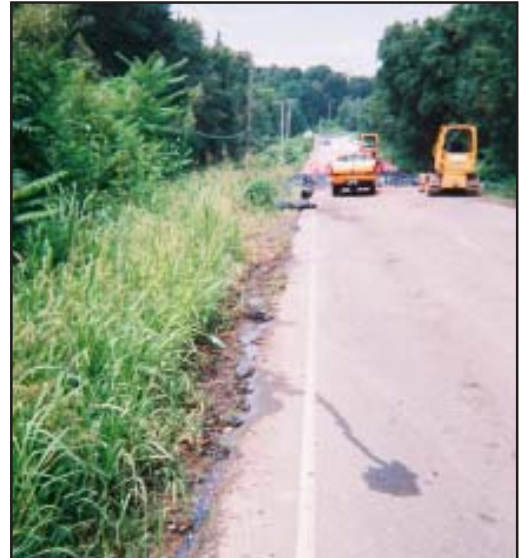
Runoff from this embankment and Route 10 in Hopewell, VA ran downhill, crossing the road above Bailey's Creek creating a major road problem which constantly had to be repaired.

Drainage of the embankment and road base would continue for days after a rainfall, as illustrated by this photo, taken five days after a storm.

VDOT workers cut a ditch and installed RainTank in the swale. With 90% void surface area and 95% void internal area, RainTank was an ideal choice to capture and carry water to a safe discharge area.

Once the tanks were wrapped in fabric, the swale was backfilled with sand and graded, compacted and seeded.

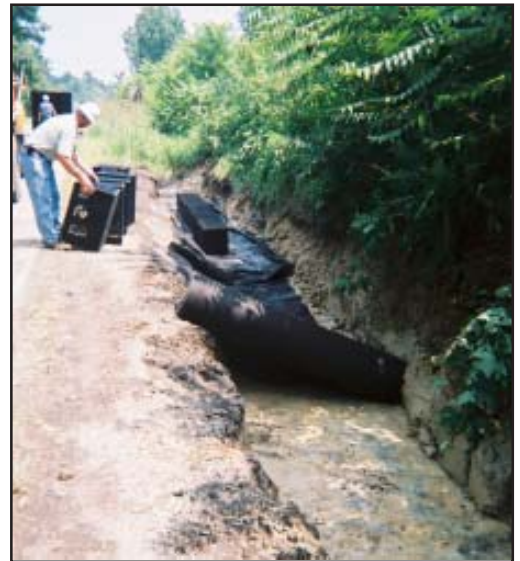
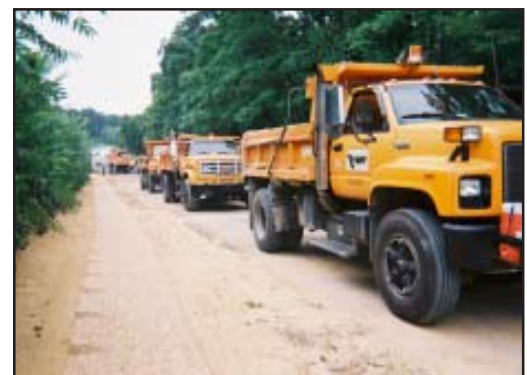
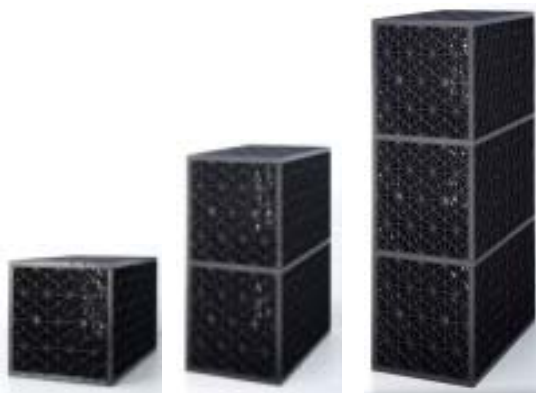
Four weeks after the installation, this area received 14 inches of rain in less than 24 hours. The system worked perfectly while suffering virtually no erosion.
