# Lake shoreline erosion problem solved with Landlok® TRM

<b>Project Name</b>	Lakes of Shorebrook
<b>Location</b>	West Palm Beach, FL
<b>Product</b>	Landlok TRM 1061B
<b>Application</b>	Lake Shoreline Protection
<b>Owner</b>	Lakes of Shorebrook
<b>Date</b>	September 1999
<b>Contractor</b>	Richard Simpson
<b>Distributor</b>	ACF Environmental

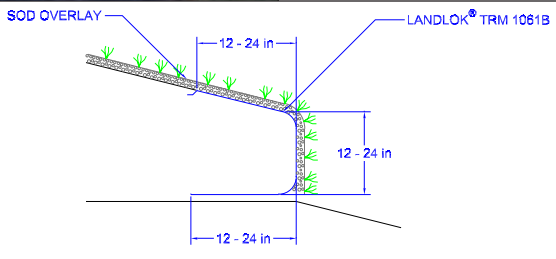
unique turf reinforcement mat has a lightweight nonwoven geotextile stitched to the back to aid in the reduction of sediment loss due to piping. The TRM was placed along the shoreline, filled with sand, wrapped and stapled to the bank and covered

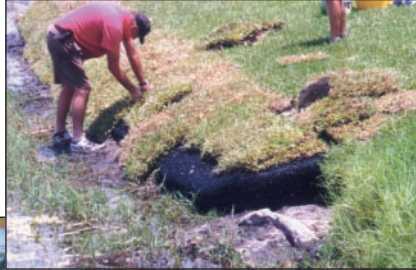
with sod. Once in place, Landlok TRM 1061B created a permanent reinforced backing for the sod durable enough that it withstood the forces of a hurricane that season.

Landlok TRM 1061B was placed, filled with sand, wrapped as illustrated in the detail and sodded. The result is a natural looking residential shoreline.
